MG TC 'stop and go' gremlins

This saga of intermittent engine failures in my 1946 MG TC is spread over more than five frustrating years.

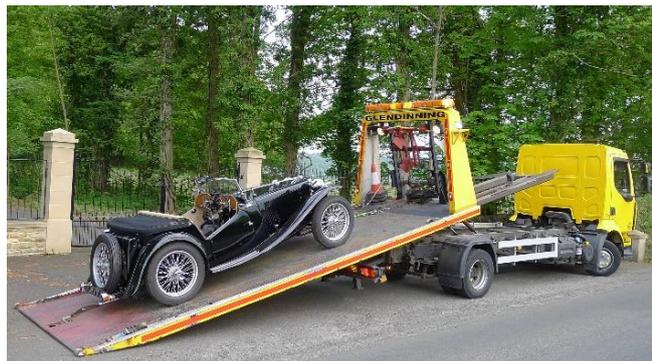
The engine usually stops after driving for at least 30 minutes, sometimes hours, and when in slow or stationary traffic. The engine often runs unevenly before stopping, but can also stop suddenly. This is more likely to happen on a hot day.

ignition failure after two hours driving

Ignition (distributor rebuilt during restoration; standard points): I've made all the usual ignition checks, and am satisfied this is working correctly, aside from occasional coil failure. The coil seems to fail when hot, working again when it cools down. However, it's difficult to be sure, as this only occurs when driving, and is short lived. This has happened with several new coils over time, so something else is clearly causing this.

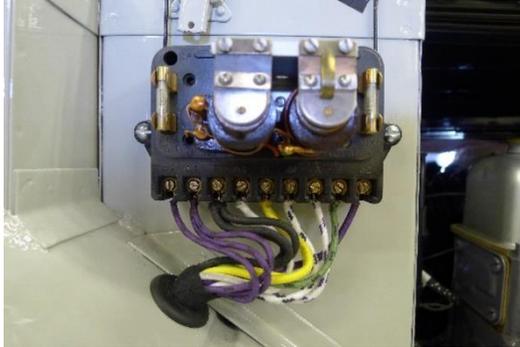
Electrical charging (dynamo and voltage regulator rebuilt during restoration; original solenoid set up): strangely, analogue voltmeter and ammeter readings show the charging system to be working correctly, but digital multi-meter readings are very erratic, fluctuating well outside the specified levels, suggesting a faulty regulator. High voltage will obviously damage electrical components including the battery, and could cause a fire!

RF91 voltage regulator (original solenoids)

I suspect the regulator may have been failing progressively over time, possibly due to a poor initial restoration. This would explain why long trips soon after restoration were trouble-free, including one trip of over 1,000 miles. The dashboard ammeter has always shown 'normal' charging levels, and the modern battery has performed well. Perhaps I should have realised earlier that recurring coil failures may be caused by overcharging. Anyway, it was the battery electrolyte spill and too many coil failures that suggested the charging system was faulty.

I've had the original voltage regulator converted to solid state electrics, and the dynamo rebuilt (refitted in May 2022). In theory, this should be a 'fit and forget' solution for reliable charging, and externally, the regulator looks original. I have also fitted a new battery and coil. After all the hassle, I decided reliability and safety most definitely trump originality.

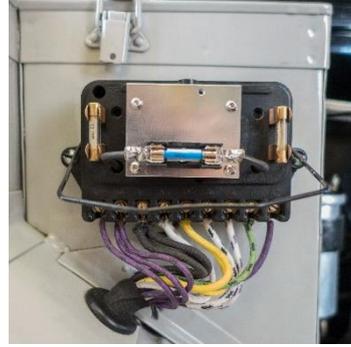
RF91 converted to solid state
