## DISTRIBUTOR GROUND WIRE

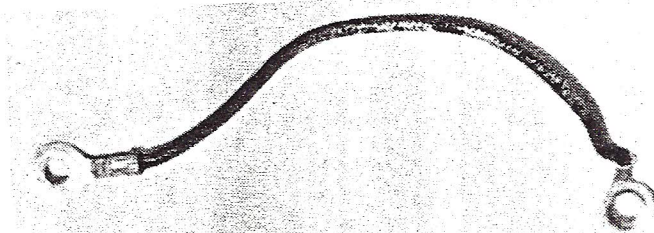
*The Mysterious Leftover Wire*

The wire in question is usually six to nine inches long, more or less, and has a 1/4 inch terminal on one end and a 5/16 inch terminal on the other. It doesn't appear in any wiring diagram I've ever seen, but in the TC and TD parts manuals it is listed as part number X31173 and is called the

This wire was supplied on the TB, TC and early TD (to XPAG/TD2/20941) because without it there is no really dependable ground connection between the distributor and the engine block. On those early engines the distributor clamp prevents the distributor from rotating in the block, but it still allows a certain amount of vibration and up and down movement. There is no really solid, permanent metal-to-metal contact between the two, so it is theoretically possible for the ground connection between them to be broken momentarily. If this happens, the engine will misfire. The ground wire, connected between the distributor clamp bolt and the center camshaft bearing locking bolt, provides a permanent, unbreakable connection.
