My car had been continually suffering from vapor lock whenever attempting to restart it after driving. With summer approaching ordered a heat shield for my TC.

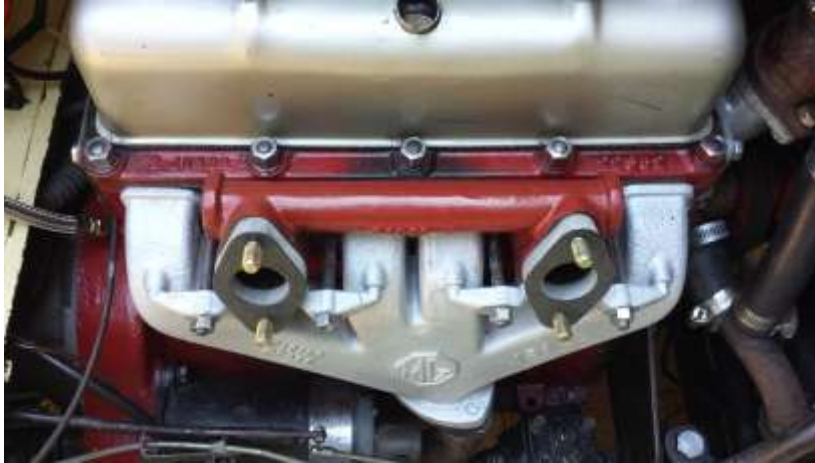
The new fuel hoses and heat shield arrived in the post within a few days of each other so all parts were removed and numerous applications of carburetor cleaner were applied. The old carburetors were black with grime and would not be fair to the maker of the heat shield to have them beside such a gleaming shiny product.

The exhaust manifold also got a touch up with some aluminum manifold paint in a spray can but I only needed to apply a little by brush so have plenty more should it wear off. I did not want to risk a manifold stud breaking off so a touch up will have to do. It was a pity that most of the coating that was good is hidden by the new heat shield.
